Manhole Inspection Summary

Manhole # S49I__024MH

Insp Date: **4/1/08 8:57 AM**

Location Address: **522 S Milton St**

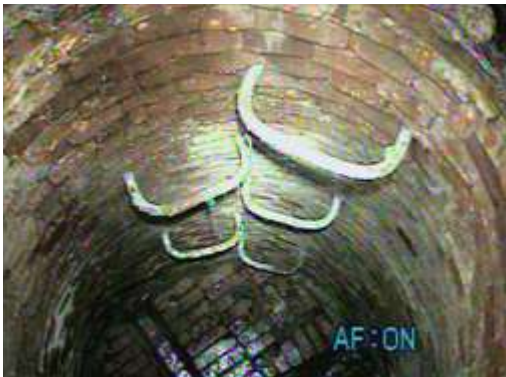
Defect 1

Count: **4** Missing: **0** ☒ **Corroded**

corroded stairs

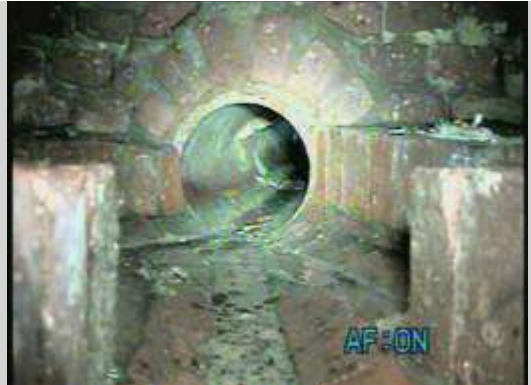
12 O'Clock Outflow

8 in. Circular Gravity Sewer
Pipe Out @ 12 O'Clock

Pipe Material: **Clay** ☐ Pipe Lined

Invert Depth: **9.05** (ft.) Flow Characteristics: **Slow**

Deposits: ☒ None ☐ Mud ☐ Sludge ☐ Debris ☐ Grease

Infiltration: **None** Pipe Seal Cond: **Unknown**

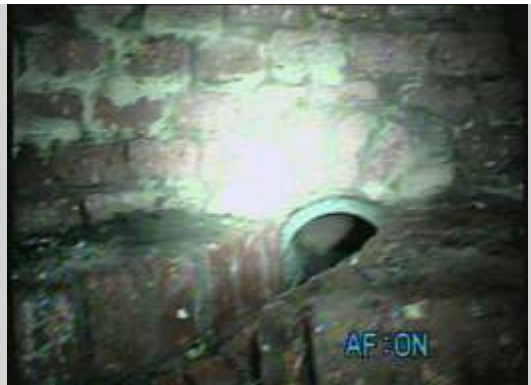
3 O'Clock Inflow

8 in. Circular Gravity Sewer
Pipe In @ 3 O'Clock

difficult angle

Invert Depth: **8.48** (ft.) Flow Characteristics: **Slow**

Deposits: ☒ None ☐ Mud ☐ Sludge ☐ Debris ☐ Grease

Infiltration: **None** Pipe Seal Cond: **Unknown**

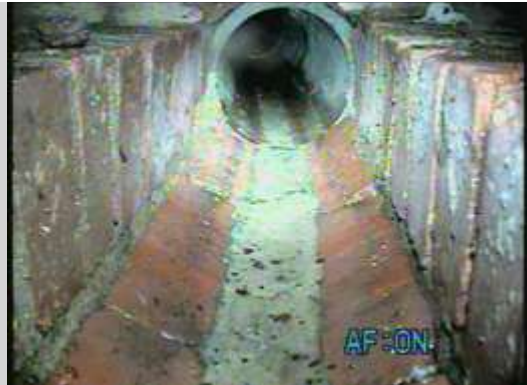
6 O'Clock Inflow

Pipe In @ 6 O'Clock

Invert Depth: **8.45** (ft.) Flow Characteristics: **Slow**

Deposits: ☒ None ☐ Mud ☐ Sludge ☐ Debris ☐ Grease

Infiltration: **None**

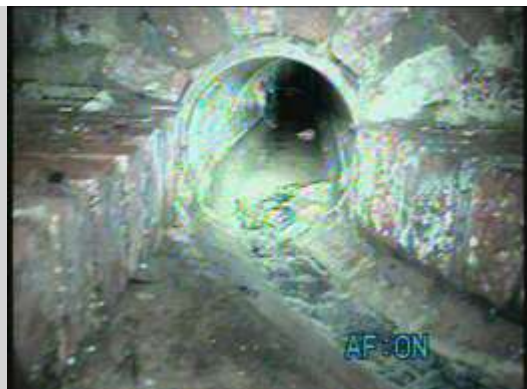
9 O'Clock Inflow

Pipe In @ 9 O'Clock

Invert Depth: **8.61** (ft.) Flow Characteristics: **Fast**

Deposits: ☒ None ☐ Mud ☐ Sludge ☐ Debris ☐ Grease

Infiltration: **None**
